Proposed Installation of Gas Fuelled Central Heating System and Associated External Flue

## Hall Bank Clinic, 1 The Savoy, Hall Bank, Buxton

New Boiler and Radiator Schedule

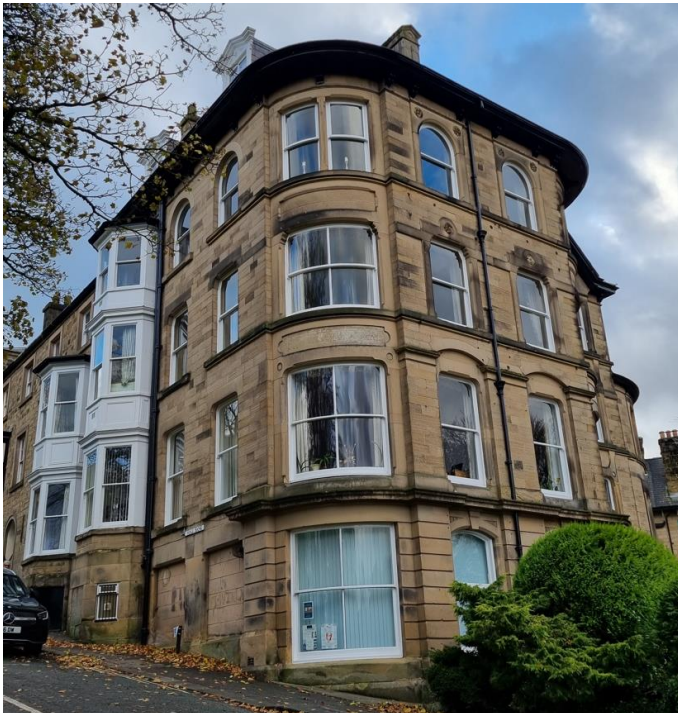
**(Figure 1 (to cover):** Front elevation of 1 Hall Bank viewed from the junction of Hall Bank and Hartington Road).

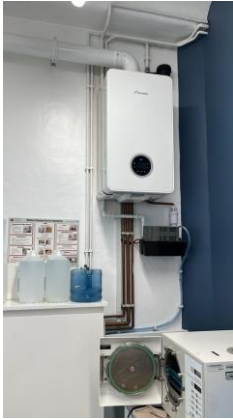
**Figure 2:** New boiler to Clean Room external wall, gas engineer has confirmed that this has been fixed to the wall using wallplugs installed in the external wall to a depth to ensure that the wall is not compromised structurally or in terms of moisture ingress. Also visible is the flue from the boiler.

The gas fuelled condensing boiler has been installed by a HETAS registered engineer to the external wall internally at high level in the Clean Room, the position being shown on the accompanying plans. Gascare as the fitters of the new gas fuelled heating system have confirmed that the boiler this has been fixed to the wall using wallplugs installed in the external wall to a depth to ensure that the wall is not compromised structurally or in terms of moisture ingress.

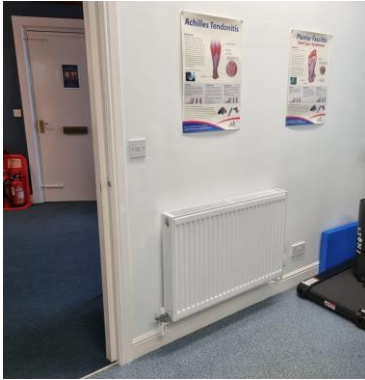
**Radiator R1:** Consulting Room 1 – new 900mm white finished wall fixed radiator, fixed to wall using radiator fixing brackets with wallplugs to wall. The wall is a modern addition to sub-divide the space at Ground Floor.

**Figure 3:** New radiator R1

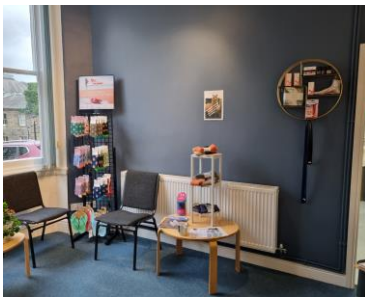
**Figure 4:** New radiator R2

**Radiator R2:** Reception – new 1800mm white finished wall fixed radiator, fixed to wall using radiator fixing brackets with wallplugs to wall. The wall is a modern addition to sub-divide the space at Ground Floor.

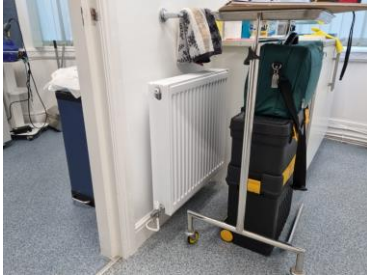
**Figure 5:** New radiator R3

**Radiator R3:** Clean Room – new 600mm white finished wall fixed radiator, fixed to wall using radiator fixing brackets with wallplugs to wall. The wall is a modern addition to sub-divide the space at Ground Floor.

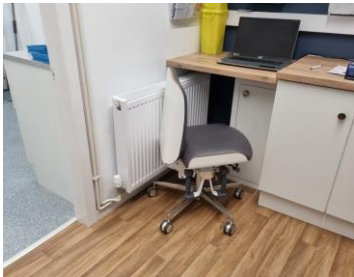
**Figure 6:** New radiator R4

**Radiator R4:** Consulting Room 2 – new 600mm white finished wall fixed radiator, fixed to wall using radiator fixing brackets with wallplugs to wall. The wall is a modern addition to sub-divide the space at Ground Floor.

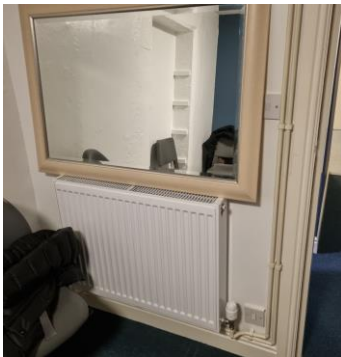
**Figure 7:** New radiator R5

**Radiator R5:** Treatment Room 1 – new 800mm white finished wall fixed radiator, fixed to wall using radiator fixing brackets with wallplugs to wall. The wall is a modern addition to sub-divide the space at Ground Floor.

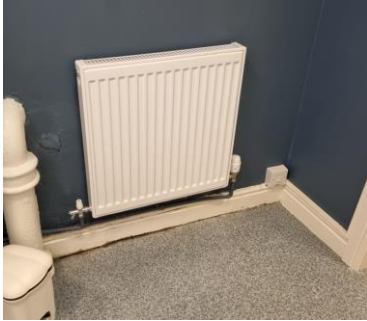
**Figure 8:** New radiator R6

**Radiator R6:** UA WC – new 600mm white finished wall fixed radiator, fixed to wall using radiator fixing brackets with wallplugs to wall. The wall is believed to be original however there is a recess in the main plane of the wall (to which the radiator is fixed) which suggests that this may have formerly been a door opening which has been infilled at some point in the last century.

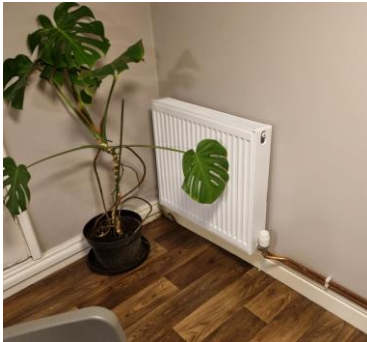
**Figure 9:** New radiator R7

**Radiator R7:** Treatment Room 3 – new 700mm white finished wall fixed radiator, fixed to wall using radiator fixing brackets with wallplugs to wall. The wall is believed to be original however it is noted to have received skirting boards at some point since completion of the building which appear non-original given their low profile.

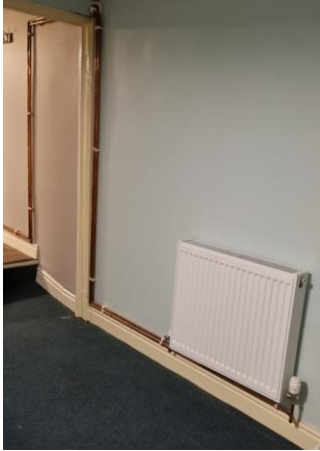
**Figure 10:** New radiator R8

**Radiator R8:** Treatment Room 2 – new 700mm white finished wall fixed radiator, fixed to wall using radiator fixing brackets with wallplugs to wall. The wall is believed to be original however it is noted to have received skirting boards at some point since completion of the building which appear non-original given their low profile.

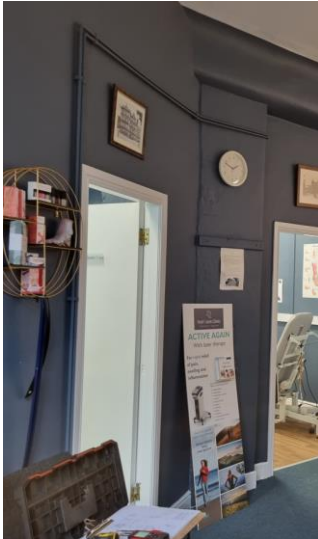
**Figure 11:** Surface fixed central heating pipework to Reception area noting the small pipe fixings to the wall.

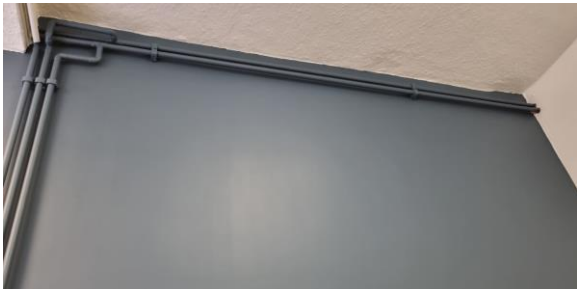
**Figure 12:** Surface fixed central heating pipework to the UA WC noting the small pipe fixings to the wall on the vertical and horizontal installations.
