# Design, Access & Heritage Statement

The Cheshire Cheese, 37-39 High Street, Buxton SK17 6HA

For Everards of Leicestershire

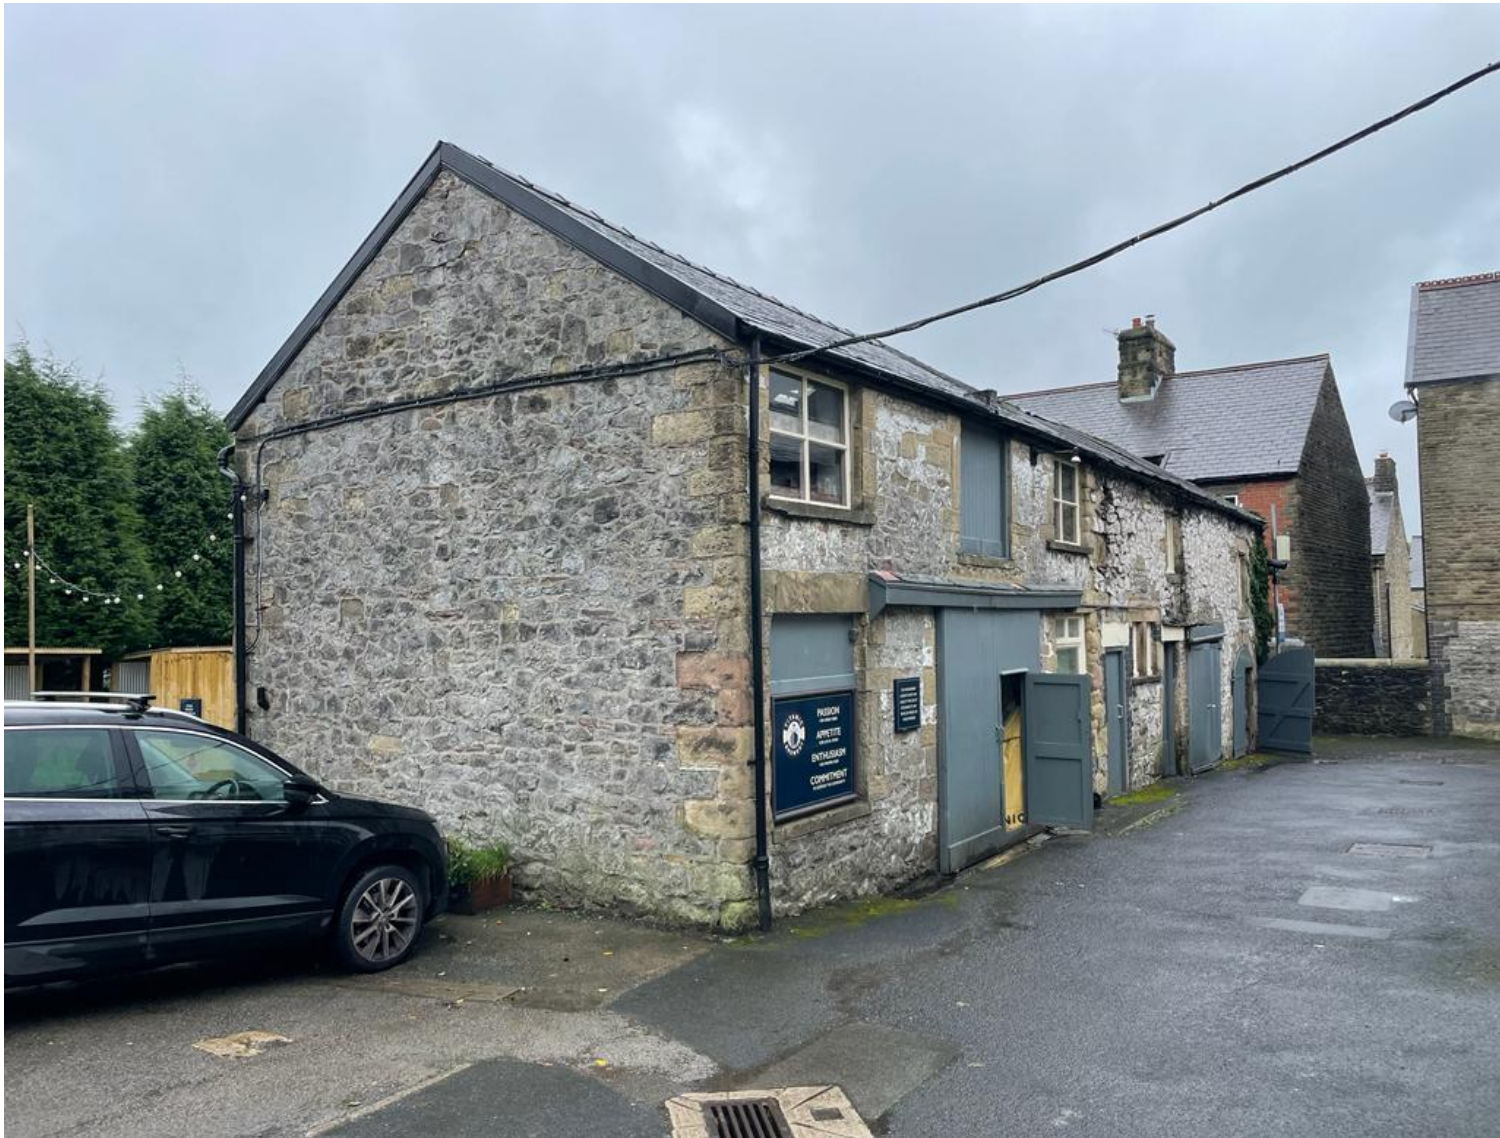
View of NW gable and front elevation of Out-building.

There is separation between the front elevation wall and the cross-walls and also between the outer and inner skins of stonework. These require stitching back together.

The building has developed somewhat haphazardly over the centuries with mis-matching rubble stonework, some dressed stone; a mixture of timber and stone surrounds. All of varying quality, condition and historic value.

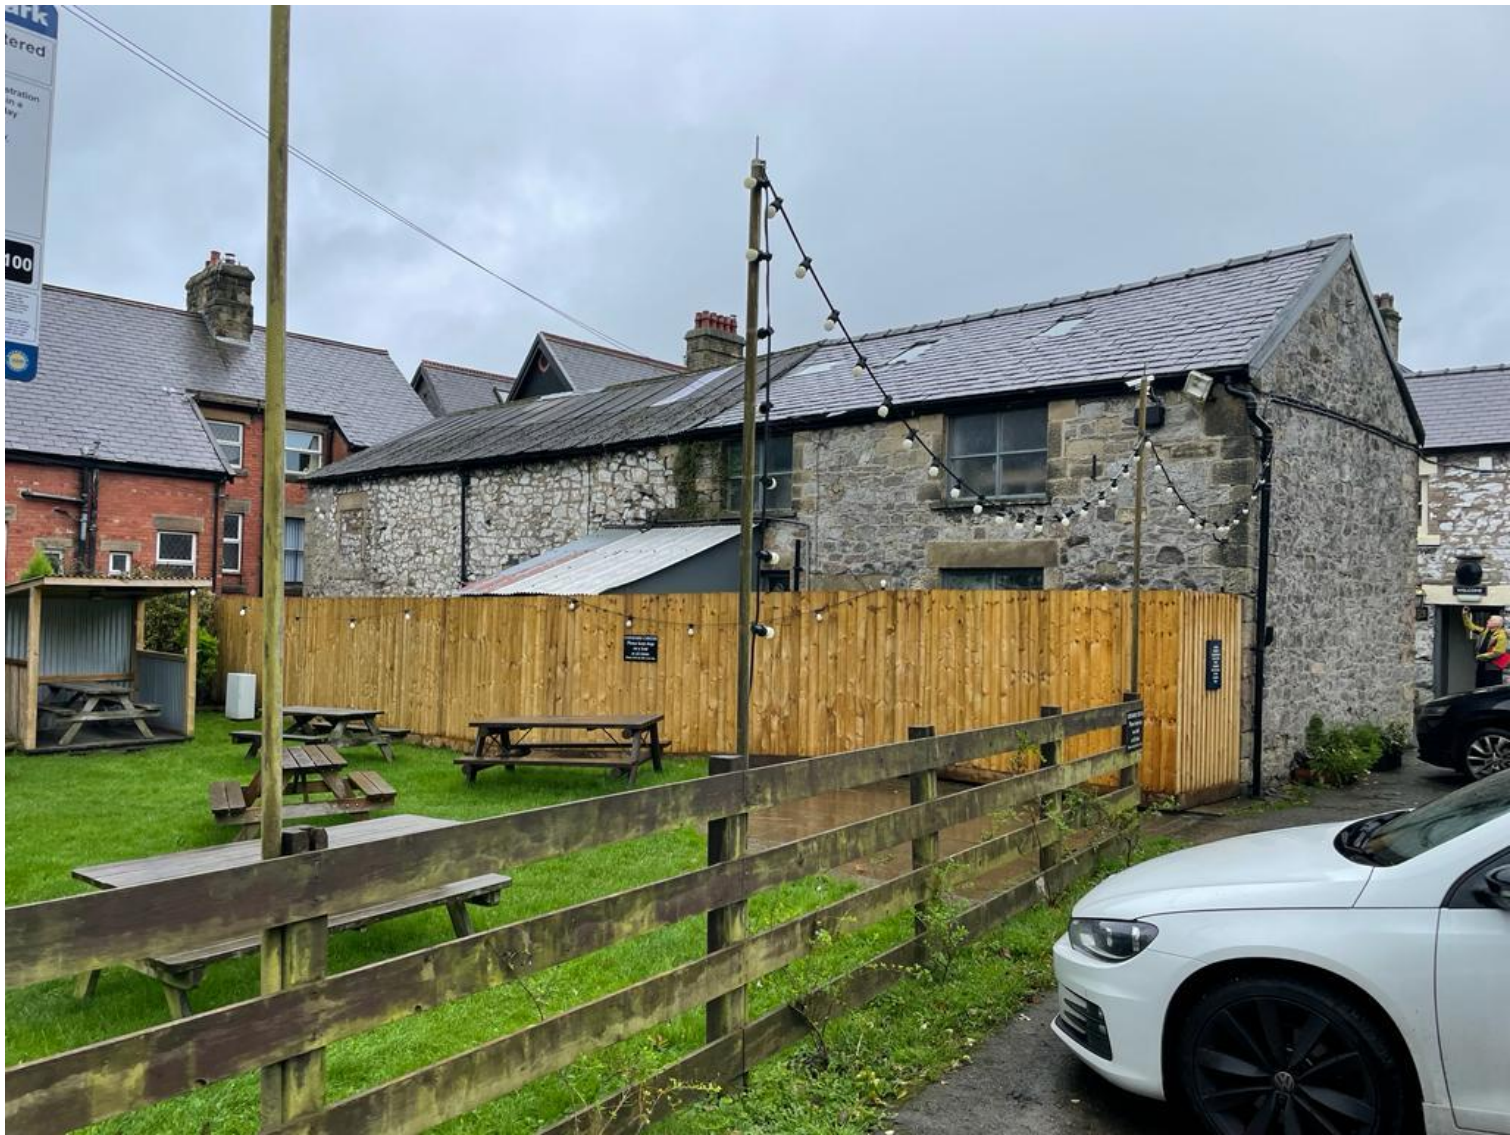
Rear of Out-building – showing part corrugated sheet roofing.

The proposal is to remove the existing corrugated asbestos sheeting that covers part of the roof and replace this section with a powder coated metal profiled sheet.

There has been no proper maintenance on the building, other than a part replacement roof covering during the 1970/1980's using corrugated asbestos sheet. The building is in poor condition and potentially dangerous to use.
