# ARBORICULTURAL IMPLICATIONS ASSESSMENT

PROPOSED DEVELOPMENT  
AT  
GLOSSOP BROOK BUSINESS PARK

Author: C. Salisbury  
Date: 17 April 2024  
Ref: TRE/GBP

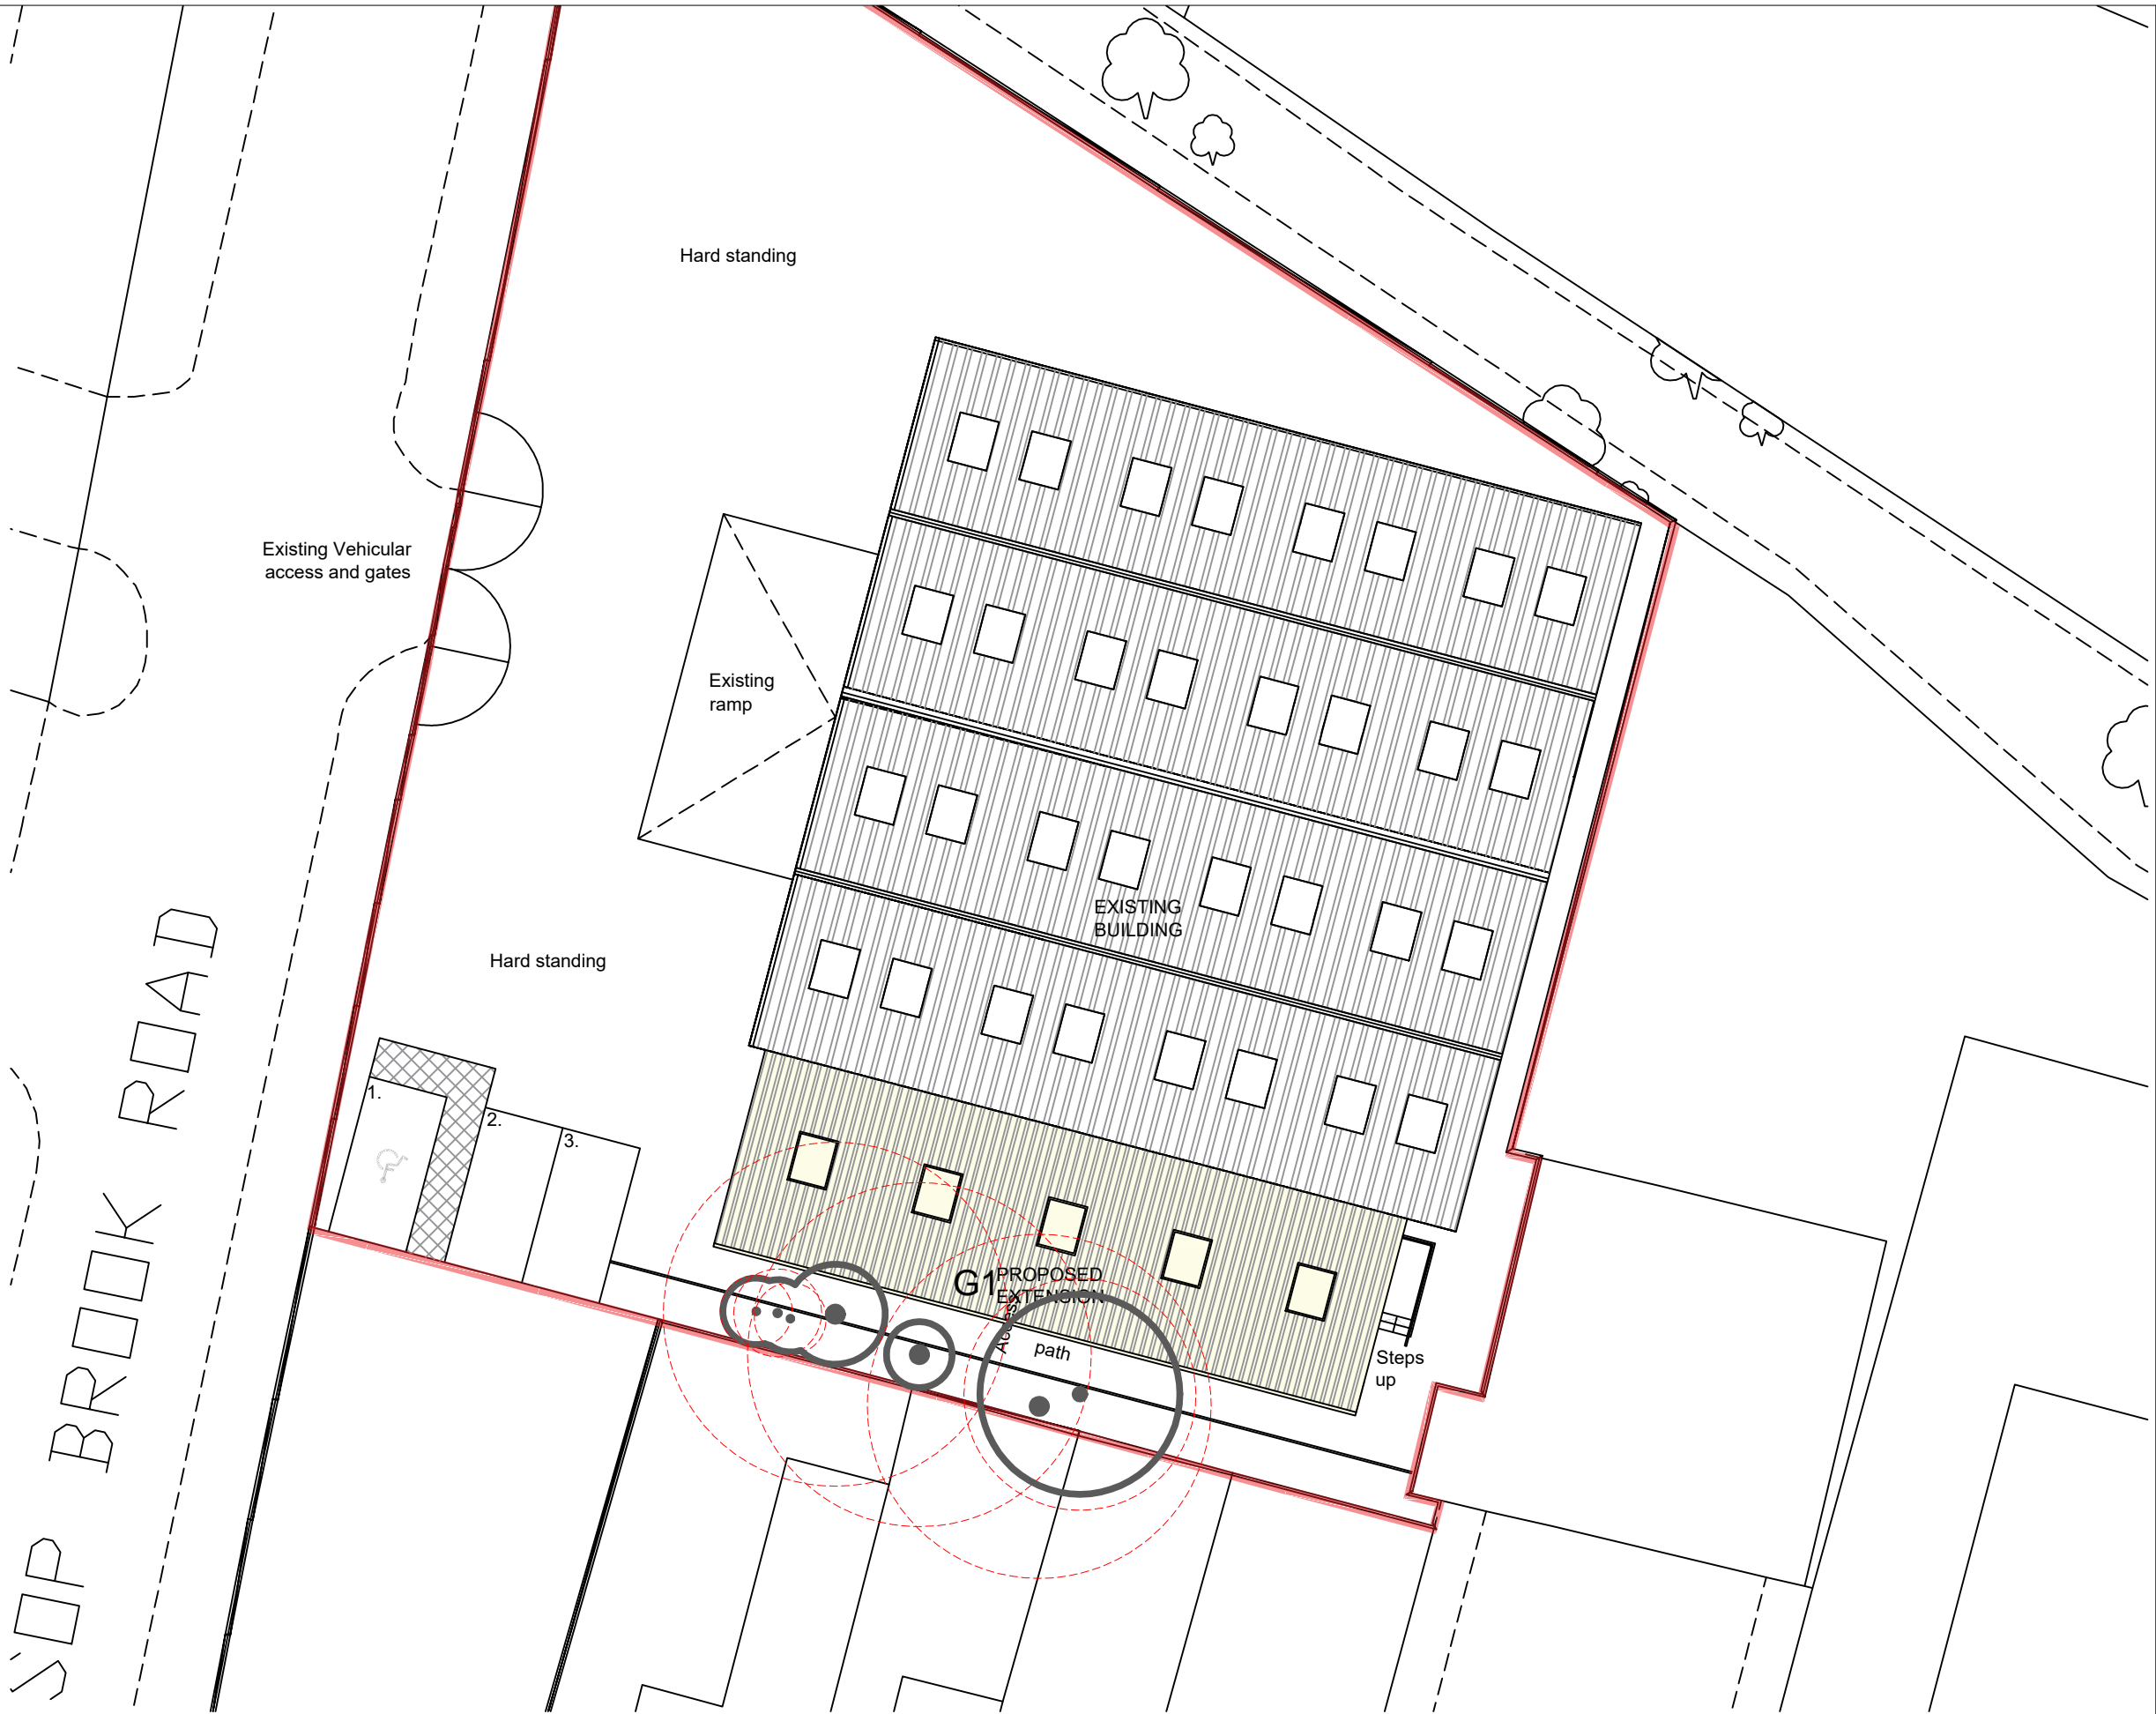
Drawing Title:  
AIS Plan

- 3.1 Due to the proposed development and its associated infrastructure there are a number of locations where the proposals are in close proximity to the trees surveyed. The Site Layout Plan within appendix three identifies the trees in relation to the proposed development.
- 3.2 In order to fully assess the impact of the proposals an Impact Table has been created detailing each tree, which shows the proximity of the associated works to the tree.
- 3.3 This can then be assessed in accordance with BS 5837:2012 to determine whether the development will have a detrimental impact on the health of each tree. Once this has been determined remedial measures can be detailed to reduce the impact the proposals will have on the treescape.
