**REMEDIATION STRATEGY FOR  
PROPOSED RESIDENTIAL DEVELOPMENT  
DINTING VALE  
GLOSSOP  
DERBYSHIRE**

**WAINHOMES (NORTH WEST) LTD**

**JANUARY 2025**

**REMEDIATION STRATEGY  
21168/REM/03**

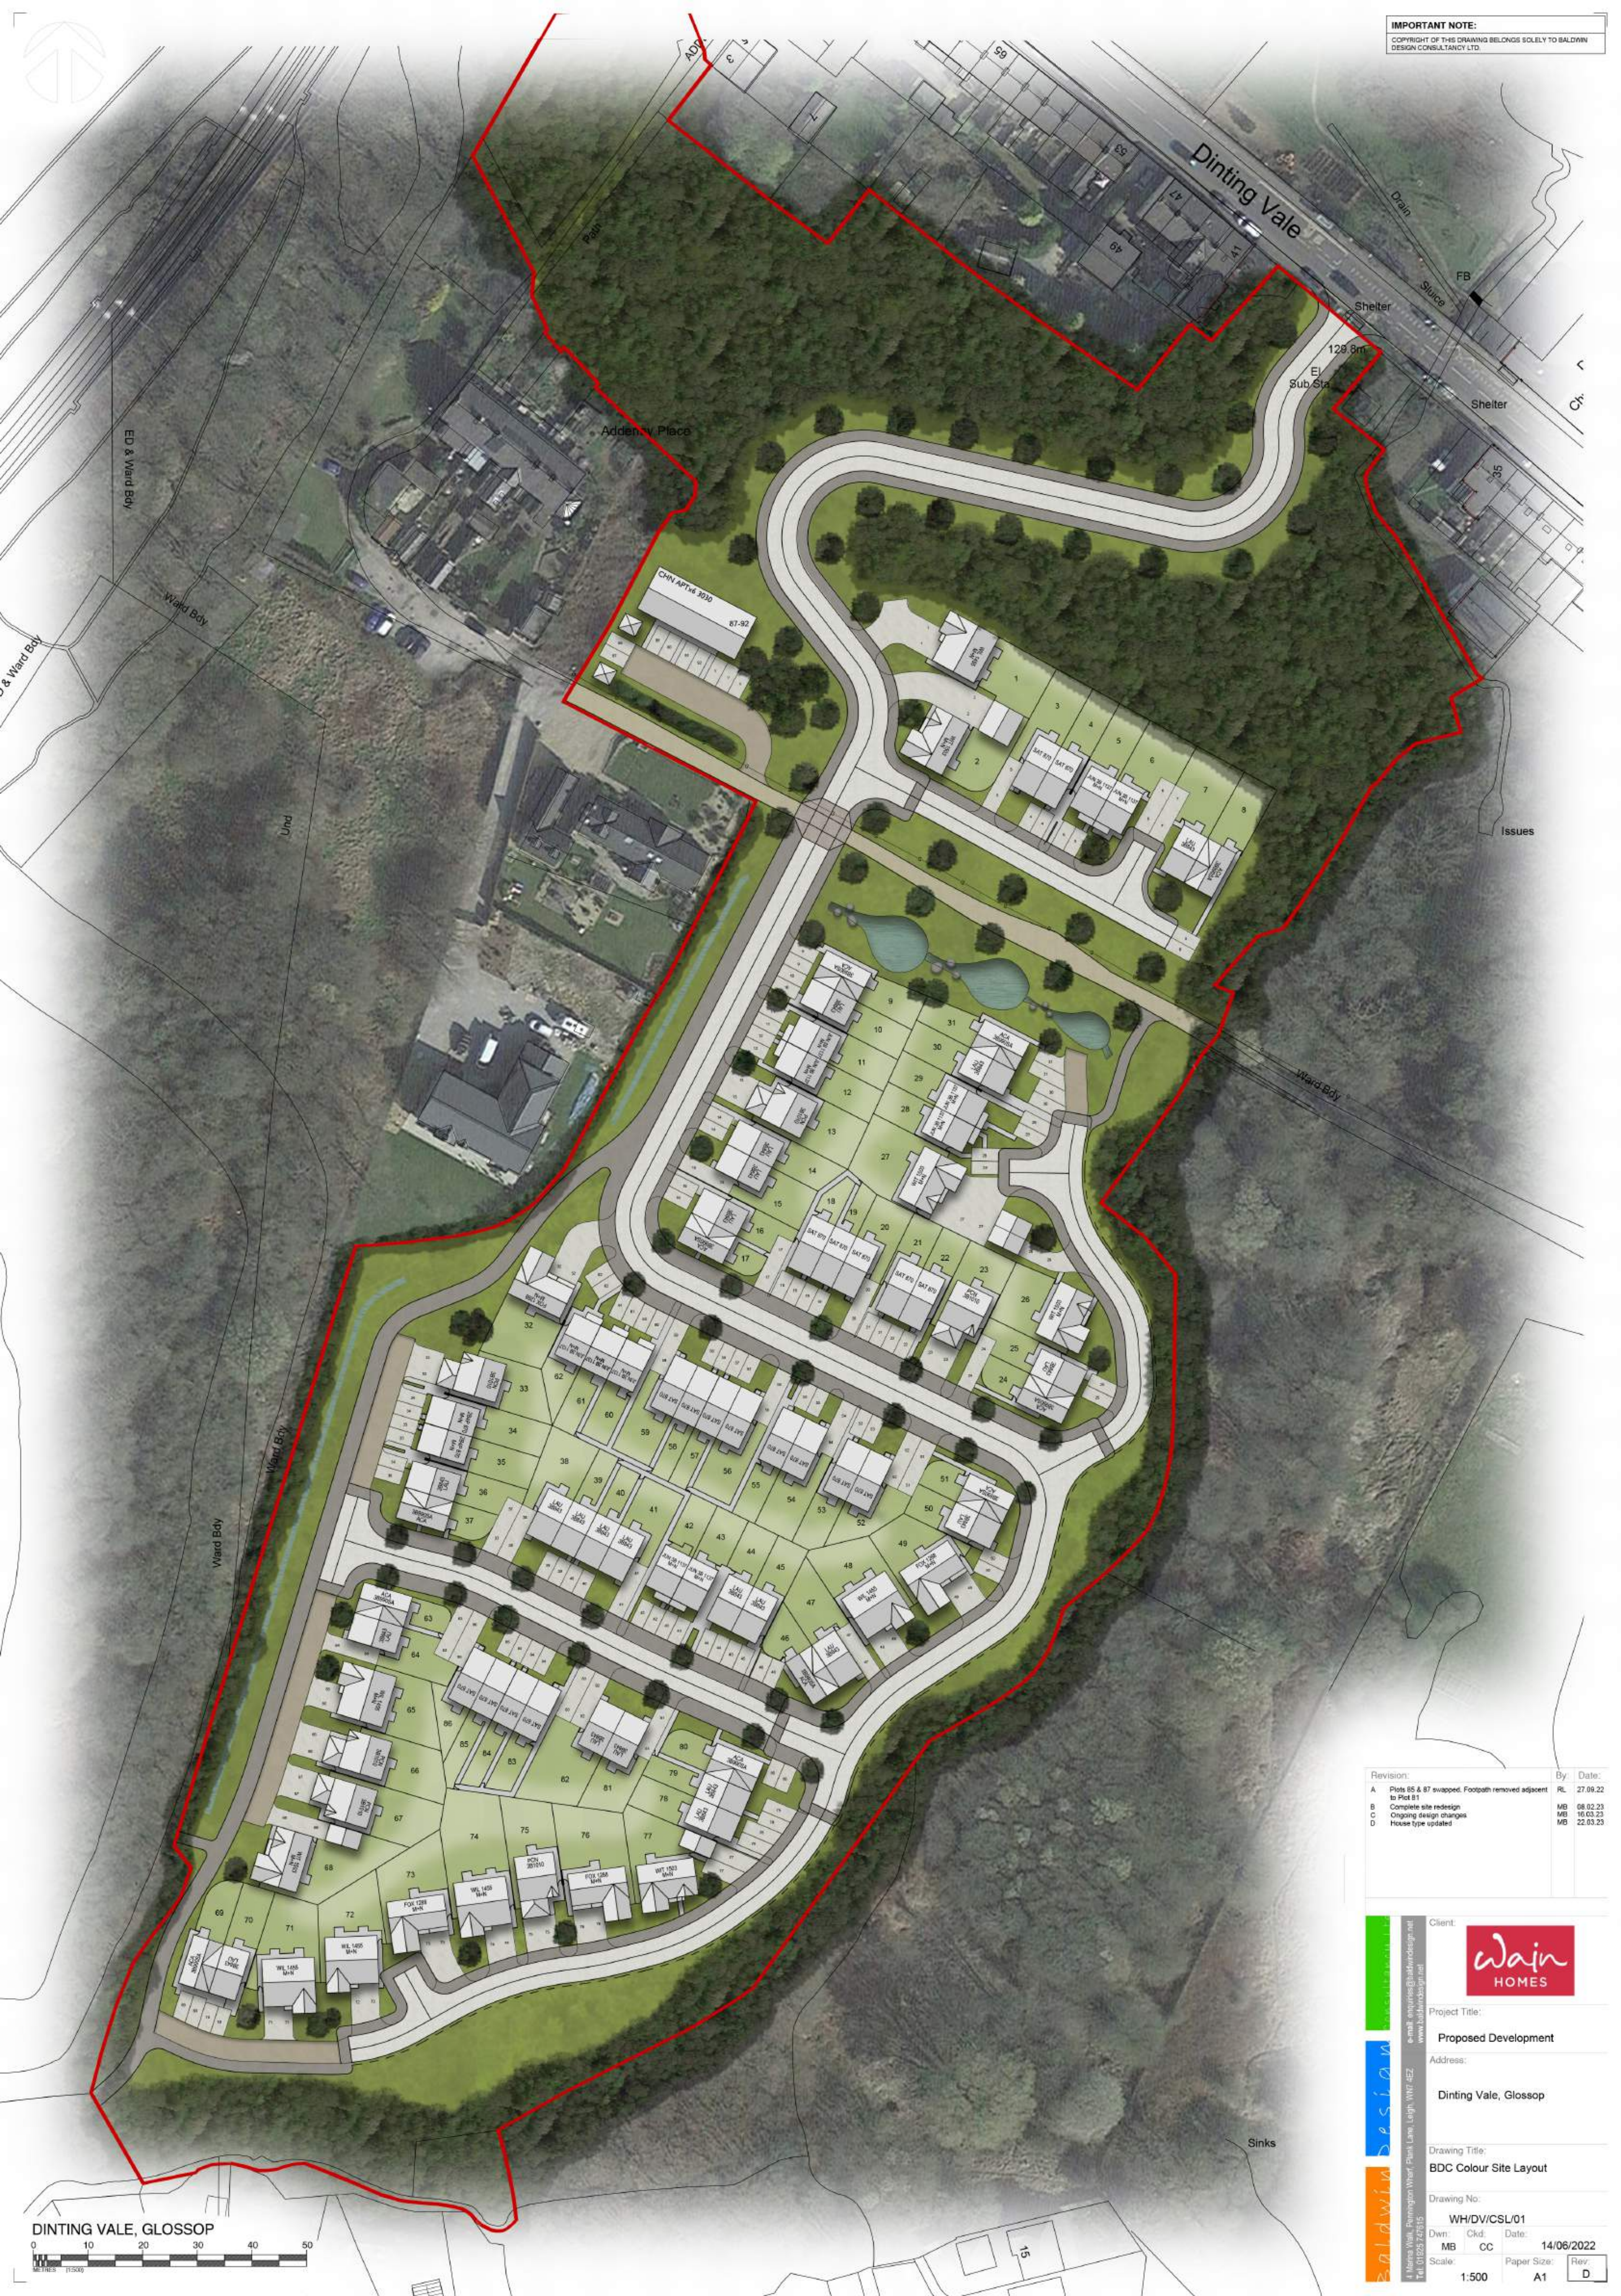
WH/DV/CSL/01

Proposed Development

Dinting Vale, Glossop

BDC Colour Site Layout

- 1.3 The site has been proposed for a residential development comprising of one hundred (100 No.) residential properties with associated road access, parking and private garden areas. A large area of POS is shown within the northern section of the site. A proposed site development plan is appended to this report for reference.
