| C | Note re second floor | 13.12.24 | PROPOSED CONVERSION OF COACH HOUSE TO THREE HOUSES AT BOWDEN HALL, BOWDEN LANE, CHAPEL EN LE FRITH, FOR MR N WEBB, PRESENT SECTIONS | Trevor Gilman Design<br>2, Roseneath, 4 Hardwick Mount, Buxton,<br>Derbysire SK17 6PP<br>07773 381824 gilmantrevor@gmail.com | | Scale 1/100 at A3 | 12.6.23 |

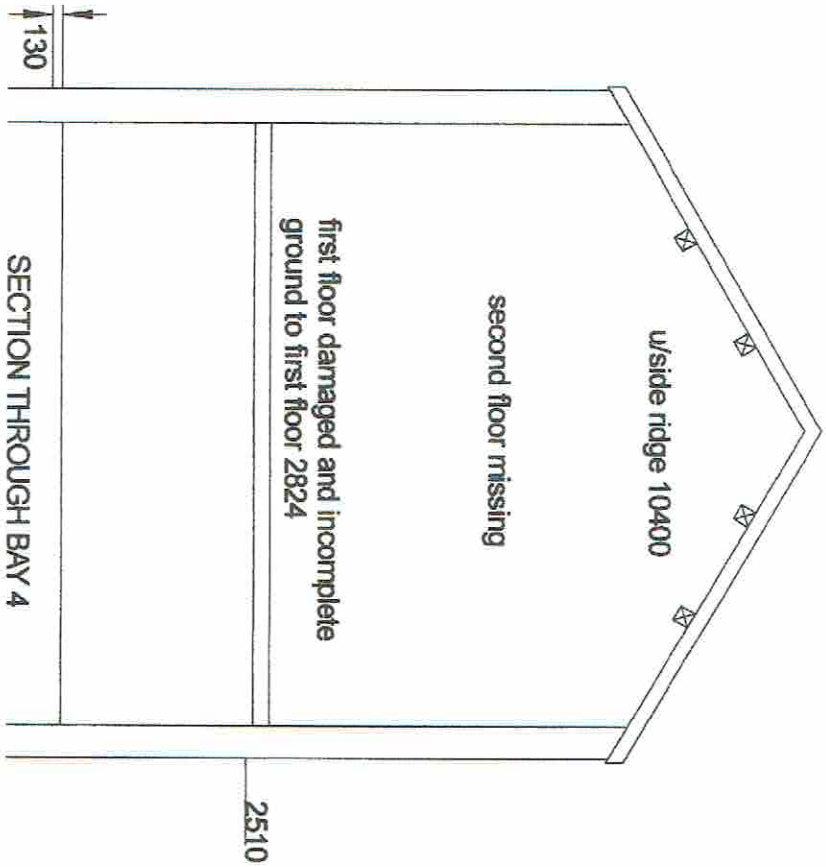
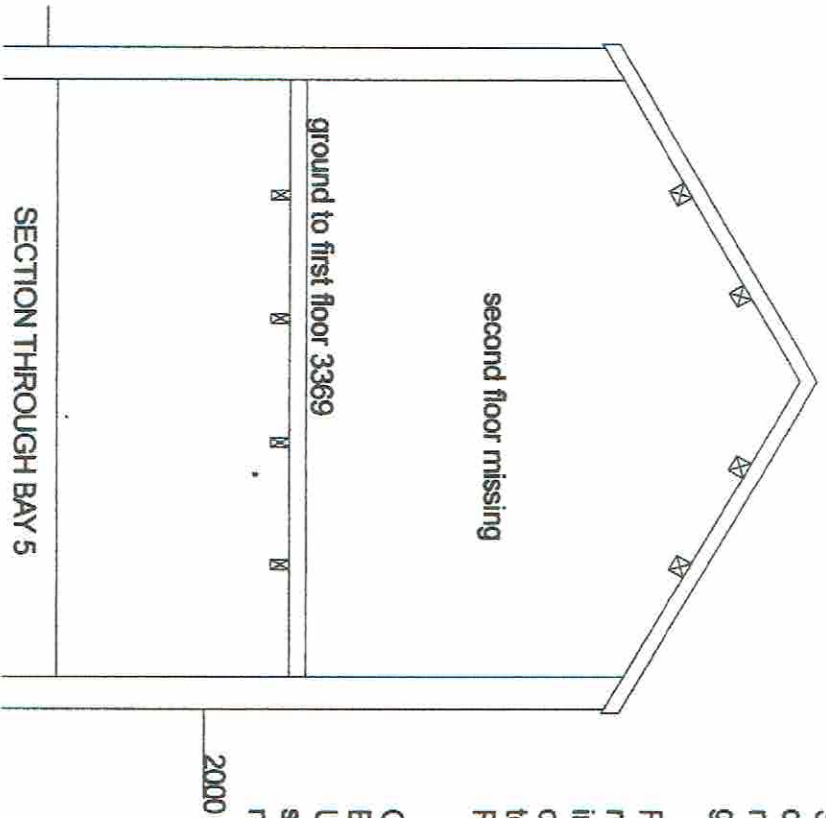
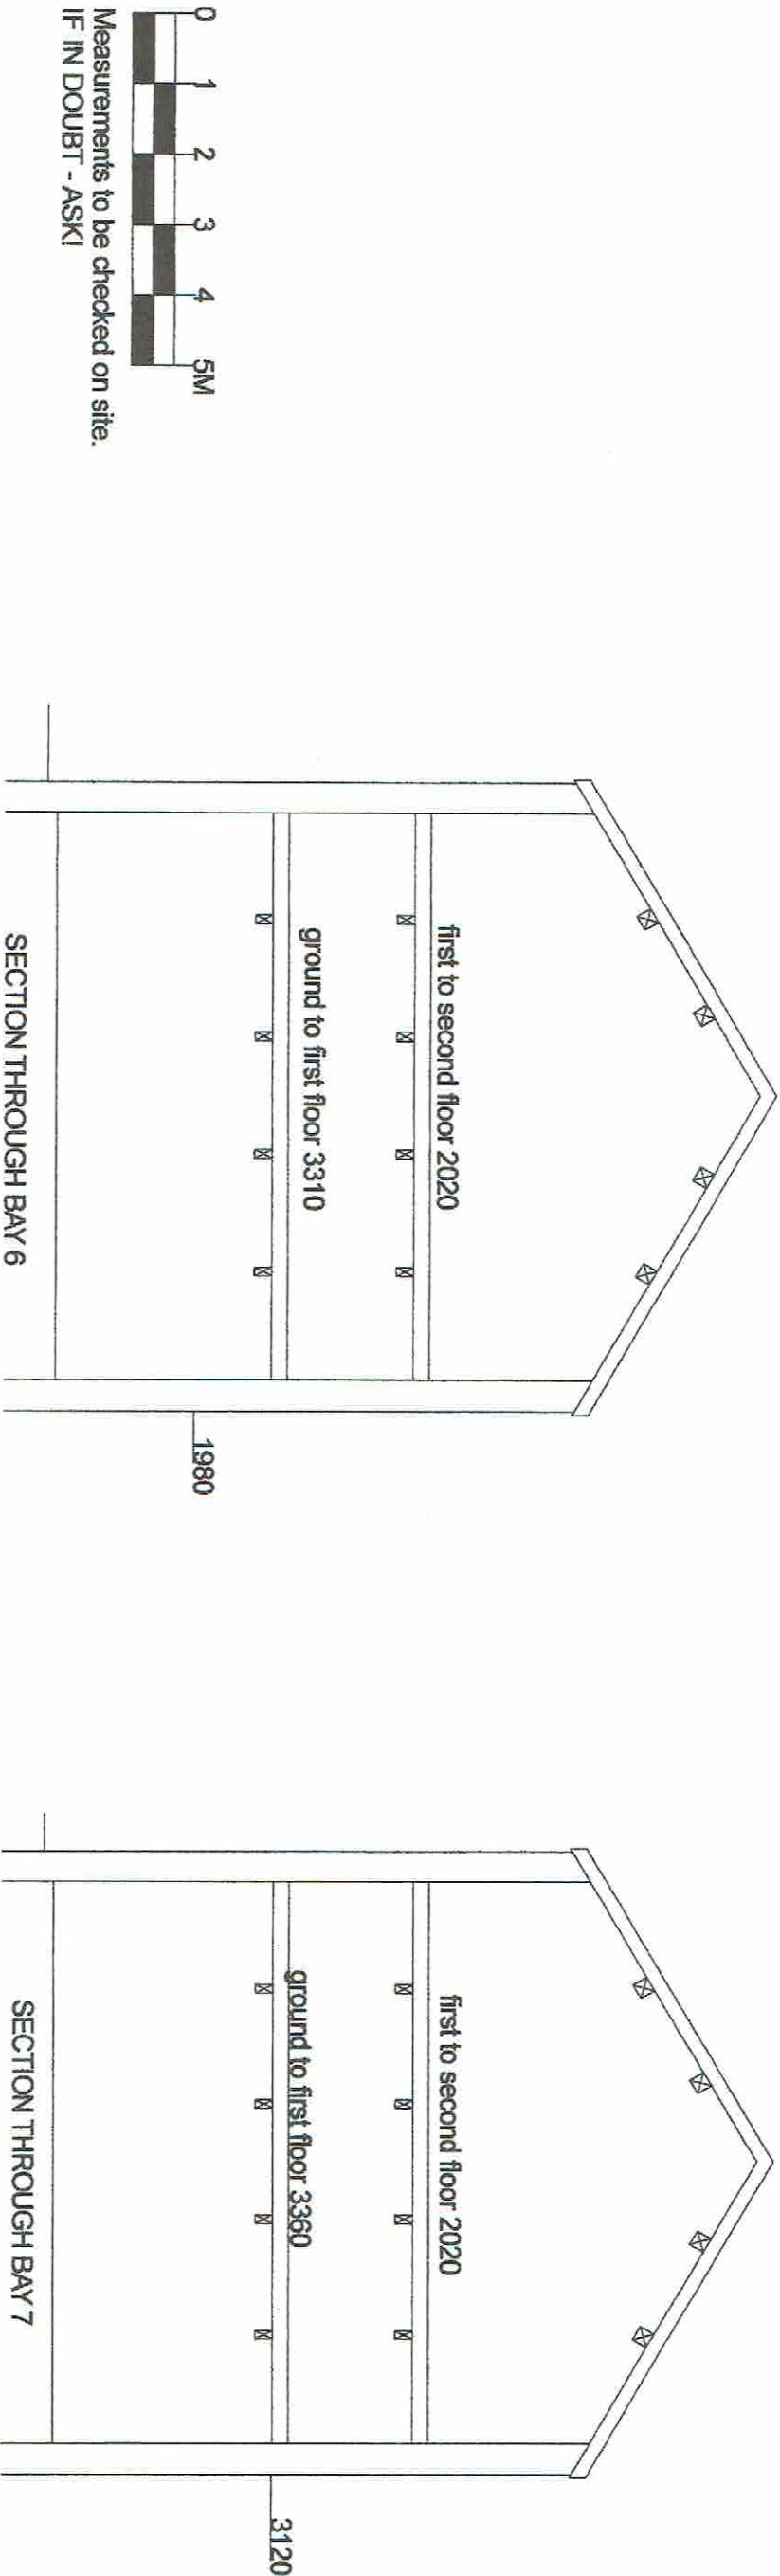
Second floor is less than 50 percent complete due to collapse or removal. This floor to be removed completely and replaced as shown to give a room height to meet Building Regulations.

First floor to be retained where possible, and repaired or reinstated as necessary. Floor to Bay 4 incomplete and will be stabilised and a new floor constructed to align with Bays 5, 6, and 7. All floors to have insulation and soffit as required by Building Regulations.

Ground floor to Bays 4 and 7 to be retained as existing. Bays 5 and 6, which will become part of Unit 2 and Unit 3 to be brought up to current Building Regulations standard by the addition of a damp-proof membrane, insulation and an approved floor finish.
